CANADIAN FORCES FLIGHT SAFETY INVESTIGATION REPORT (FSIR)

FINAL REPORT

FILE NUMBER: 1010-C-GCLG

AIRCRAFT TYPE: Schweizer 2-33 Glider

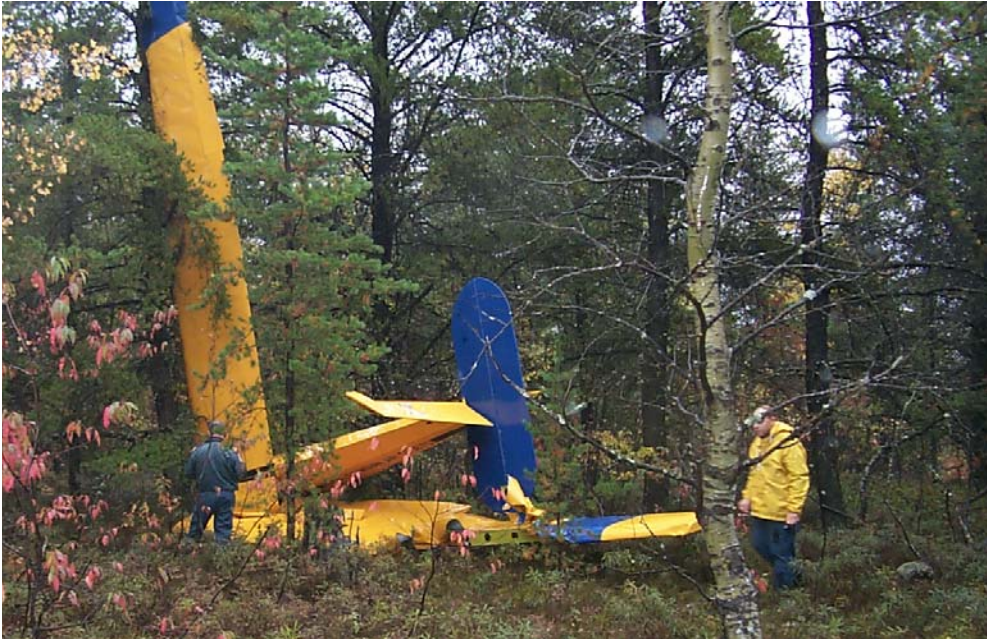
The crash site was about 1500 feet from the launch point and 1000 feet short of the button of Runway 18. (Annex B) It was located in an area of dispersed mature pine trees, most approximately 40 feet tall. The initial impact occurred when the leading edge of the left wing contacted one of these trees, approximately 14 feet from the fuselage. This caused the aircraft to pivot about the point of impact and the leading edge to be peeled away from the spar towards the wingtip. The top of the tree was bent, severed and thrown back along the flight path. The glider turned left through about 90°, to an easterly heading, as the right wing rose to a vertical position. The glider descended to the ground, with the left wing folding under the fuselage, as the leading edge of the right wing was directed by large branches to the trunk of the tree, against which it eventually came to rest. The canopy broke as the fuselage slid to the ground.

Photo 1 Overview of Crash Site from Rear

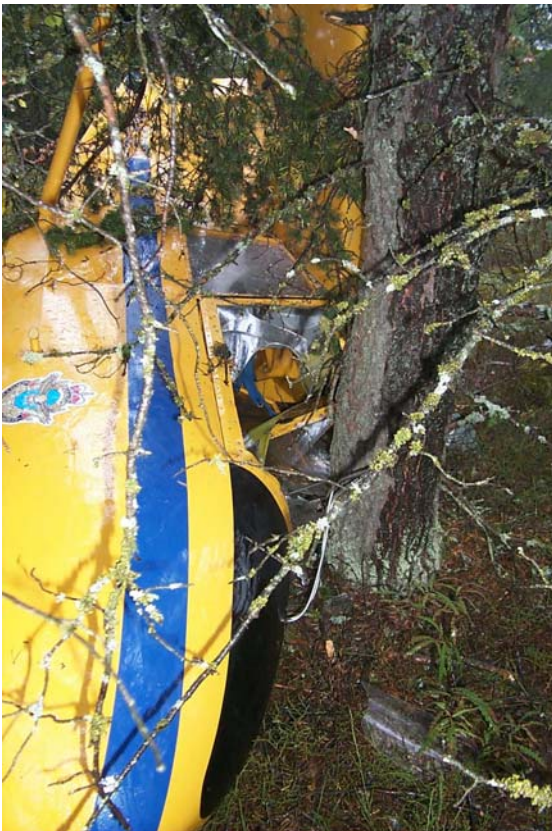
Photo 2 Detail of Cockpit against Tree

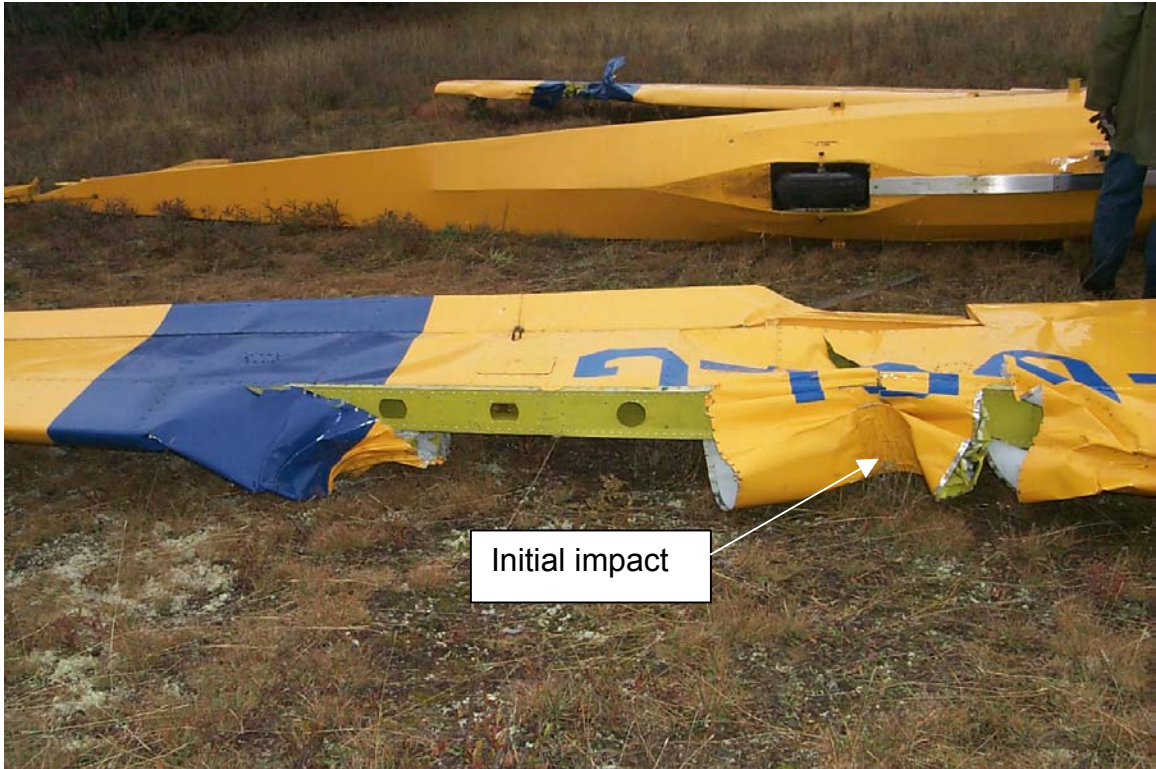
As a result of the accident, the glider suffered B category damage. The damage consisted of a broken canopy, a bent pitot tube, severe damage to the left wing. (Annex A Photo 3) The right wing was also damaged receiving a large rip in the leading edge, ahead of the aileron, which extended back to the spar. (Annex A Photo 4)

Photo 3 Impact Damage - Left Wing

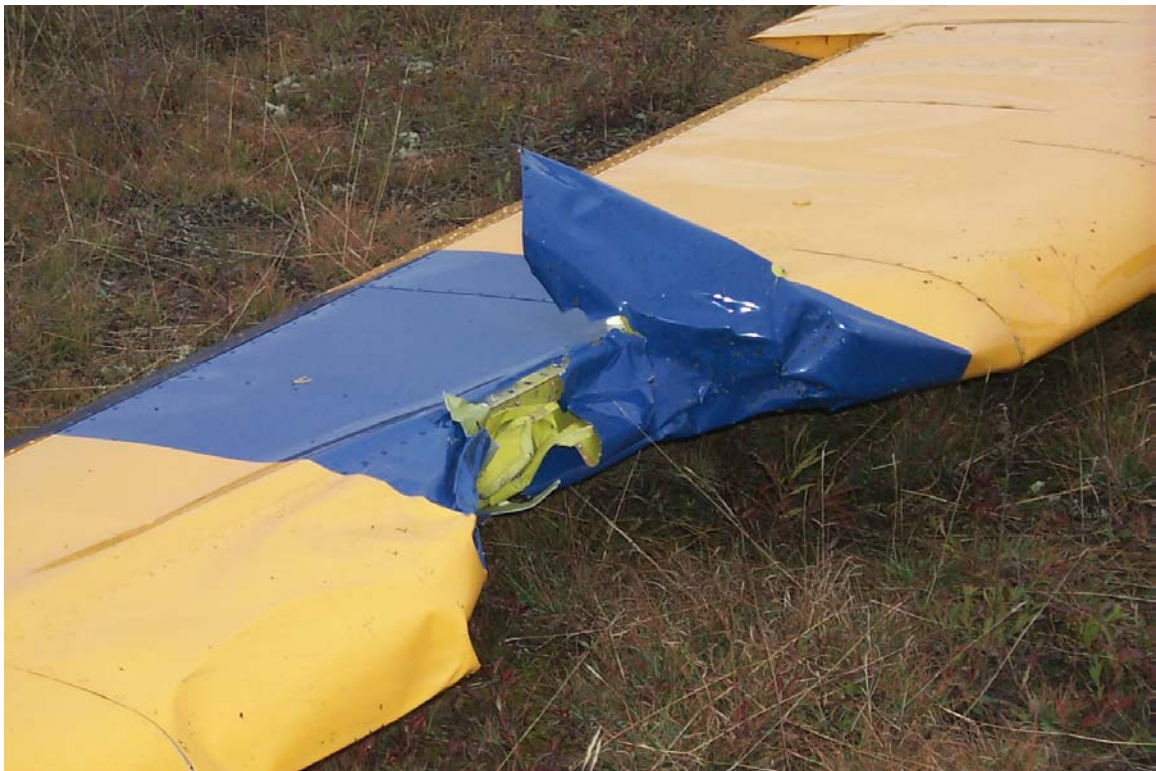
Photo 4 Impact Damage - Right Wing

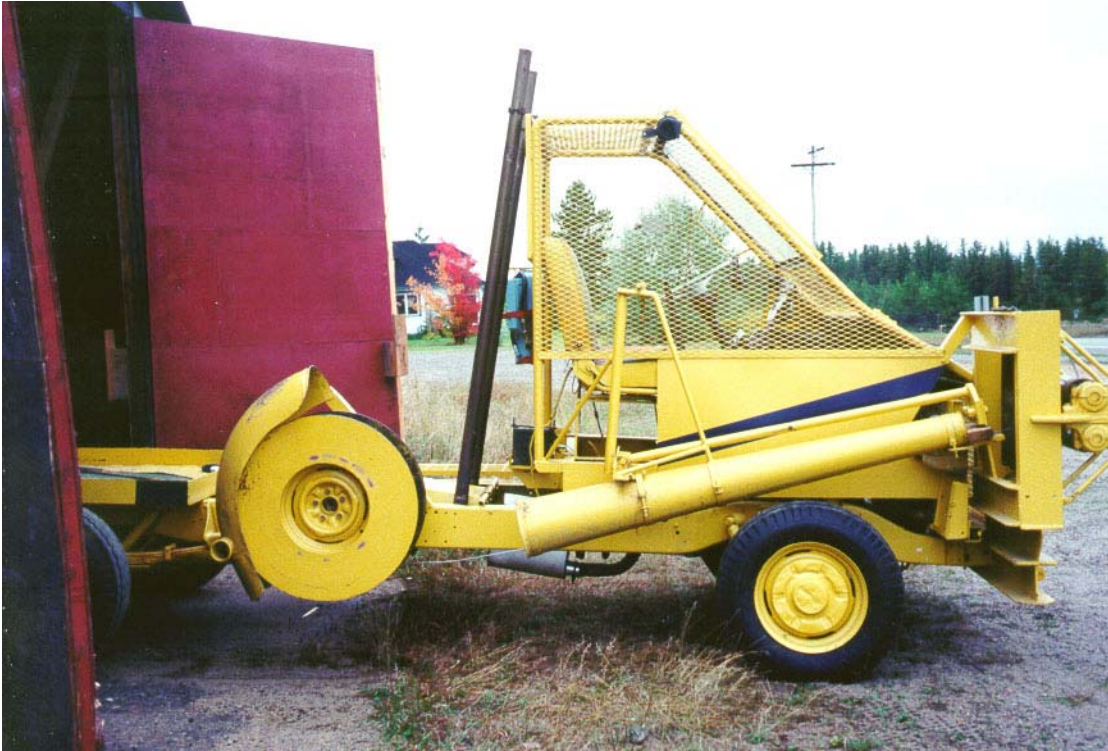
The Winch utilised at this site was constructed locally and is unique in design from those used at other locations. This winch did not have an amber light affixed to the top (Annex A Photo 5), as required in A-CR-CCP-242 ACGP Manual (Annex C Ref C). On a typical winch this light is activated by the ignition switch and is used to confirm to launch personnel that the operator has started the winch in anticipation of a launch.

The winch in use at Iroquois Falls is of a unique design. Being self-propelled, its engine is kept running constantly except during rest and meal periods. This fact defies the rule on rotating beacons as described in the A-CR-CCP-242, which is that the rotating beacon must be illuminated any time the ignition is on thereby warning personnel on the site that a glider launch is about to take place. If this winch were equipped with a rotating beacon in accordance with regulations, its constant operation would desensitize personnel to the dangers for which it was designed for. Alternative means of visually indicating that a launch is about to take place should be developed, at this site, which recognizes the unique design and operation of this winch. A-CR-CCP-242 must be amended to mandate a visual warning system that considers the launch status and not the engine status.

Photo 5 Winch in Use at Iroquois Falls

4.2.2 The direction contained in A-CR-CCP-242 with regards to the need for an amber light should be clarified for non-standard winches. Winches should be required to have a rotating beacon that will indicate that the operator has engaged the drum and is about to launch a glider.

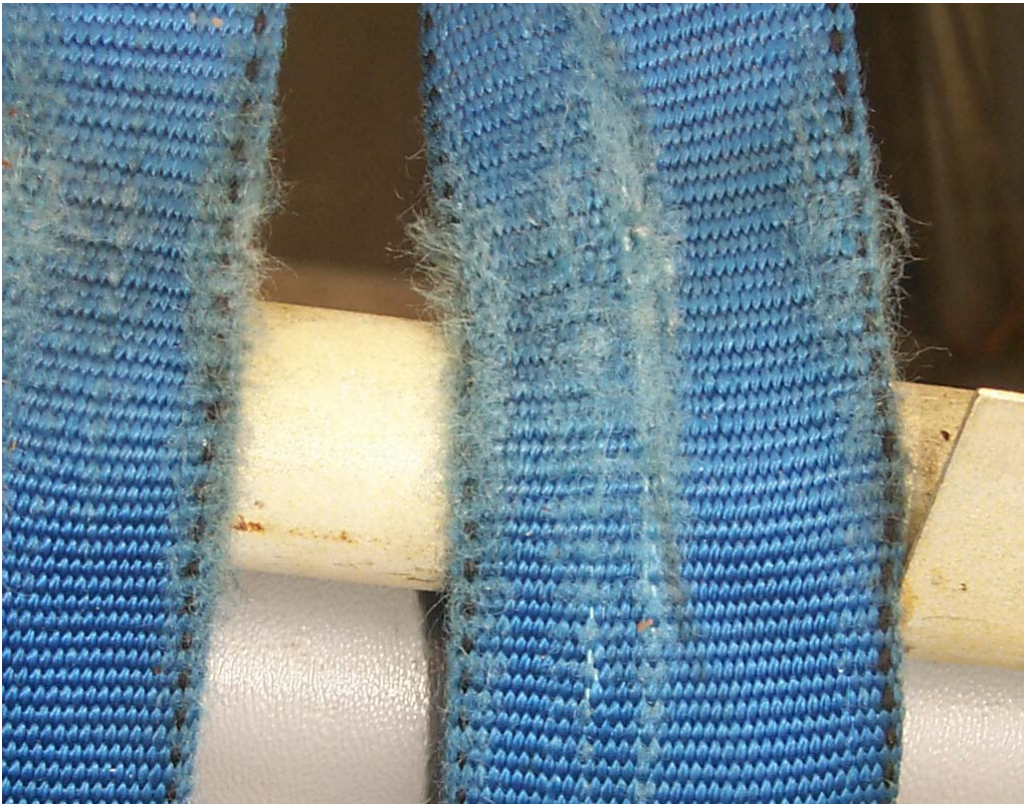
Both harnesses were sent to DCIEM in Toronto for analysis (Annex C Ref E). They showed signs of extensive use and stretching. The buckles showed signs of corrosion. The rear harness was the weakest and showed some signs of breakage with a load of less than 1000 PSI. It finally broke in two at 1650 PSI. Such failure does not meet current CF standard which requires no signs of breakage below 1000 PSI (Annex C Ref E). Although this standard does not apply to restraints in civilian aircraft, it certainly reflects the benchmark one would expect to apply to aircraft used by the CF. Fortunately, this crew was only subjected to lateral forces as the glider slid sideways along the tree. Had the occupants been subjected to forces that would otherwise have been survivable, it is possible that the rear harness would have failed and might have contributed to more serious injuries.

3.1.8 The harnesses of this glider were degraded to the point that even with survivable impact forces, it might have failed.

Photo 6 Frayed Shoulder Straps

4.1.4 All harnesses for all three Air Cadet fleets (gliders and tow aircraft) were replaced. The inspection checklists for the three fleets were amended to include a more thorough check of the harnesses. In addition, harness inspection criteria, source of spares and overhaul facilities have been discussion topics at Maintenance Review meetings for the last two years. Harness condition is now an item that is specifically checked during biannual audits of the maintenance facilities.
